CRYSTAL LAKE DAM

NH 00269

PHASE I INSPECTION REPORT NATIONAL DAM INSPECTION PROGRAM

NOVEMBER 1978

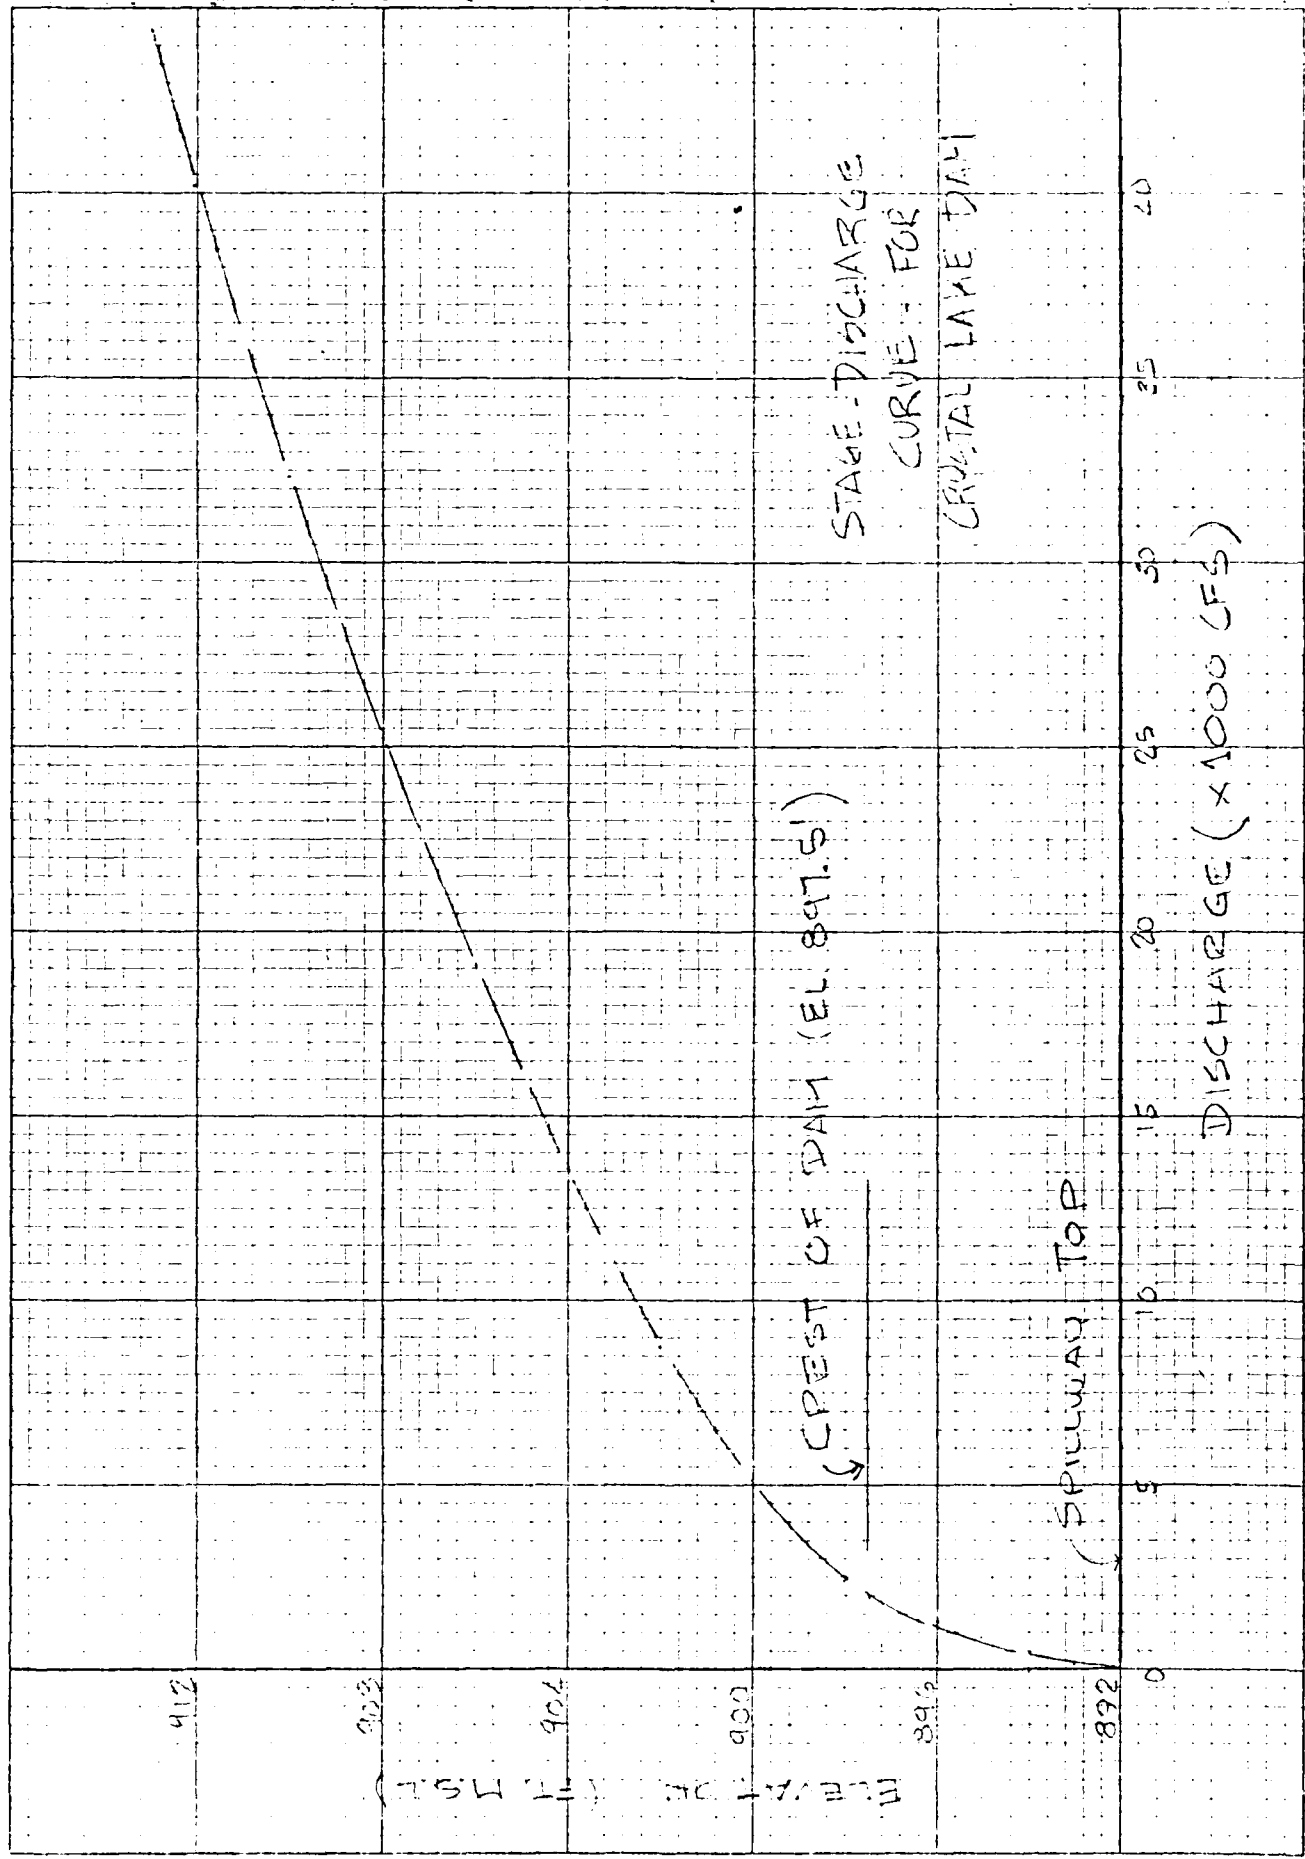
FIG. 1

From Fig. 1 The surcharge Elev. 899.20' MSL

1. The test flood discharge $Q_{P_5} = 5,400 \text{ CFS}$ will overtop the dam by approx. 2.7 Feet.
2. The spillway (50-FT Long) with crest elev. 892' MSL and with water surface 897.5' has a capacity of 1950 CFS which is the 36.1% of the test flood discharge.

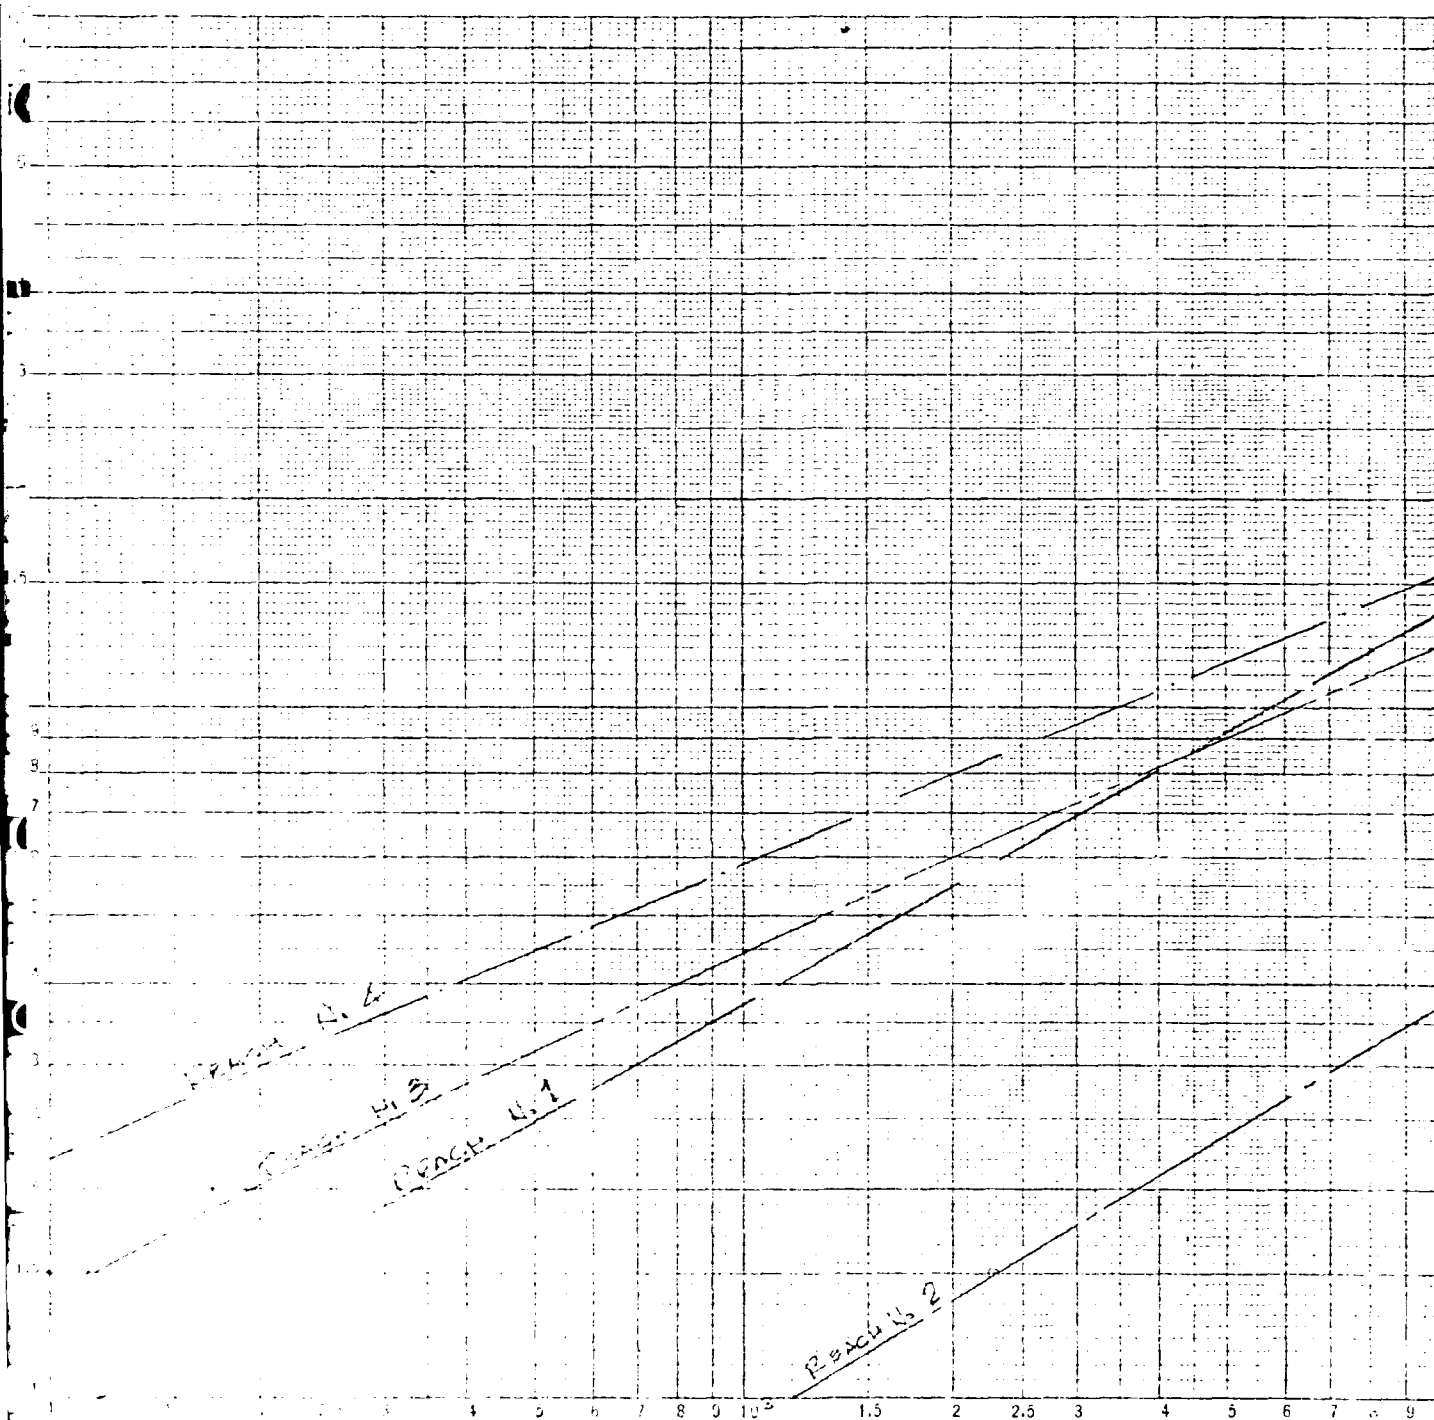
FIG 2

A. Using Curve No. 4 (Fig 2) the corresponding stage for $Q_{P2} = 5,320 \text{ CFS}$ is 11.83' and the area = 978' / compute Volume V_1
